REWILDING
SUDOESTE

**EMERGENCY
POST-FIRE
STABILIZATION
MEASURES**

This small guide aims to present some immediate and general solutions to the main problems that arise after the passage of a large fire.

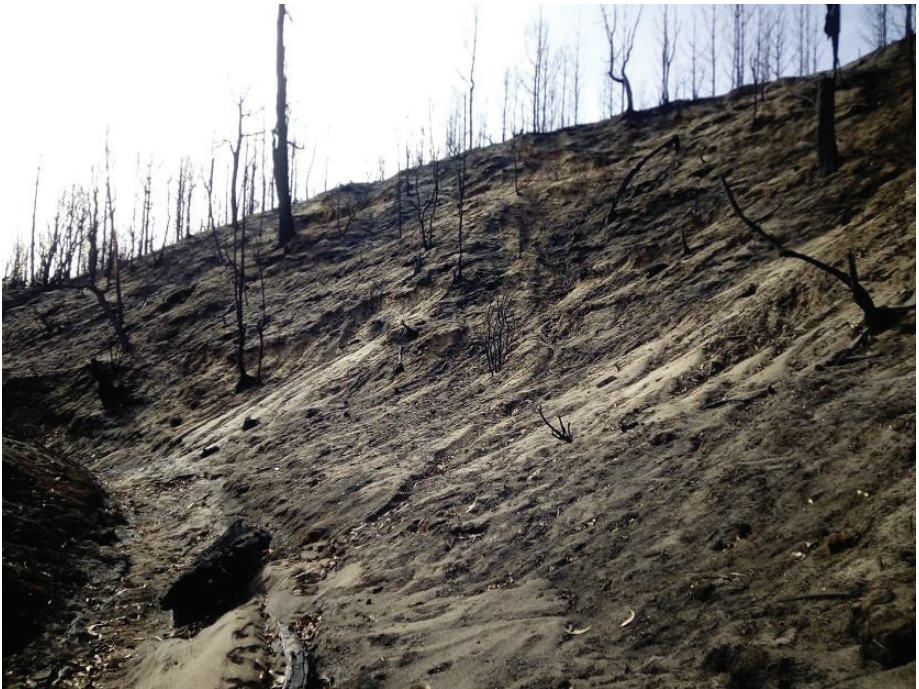
Image 1 - Example of a slope to be preserved (Source: ICNF)

Firstly, it is important to **identify the places most susceptible to erosion and torrential phenomena** (see Image 1):

- areas most exposed to wind (north and west facing slopes, ridges);
- areas with more sun exposure (south-facing slopes, sunny sites);
- areas with a steeper slope;
- areas that have been cleared of vegetation with heavy machinery (firebreaks).

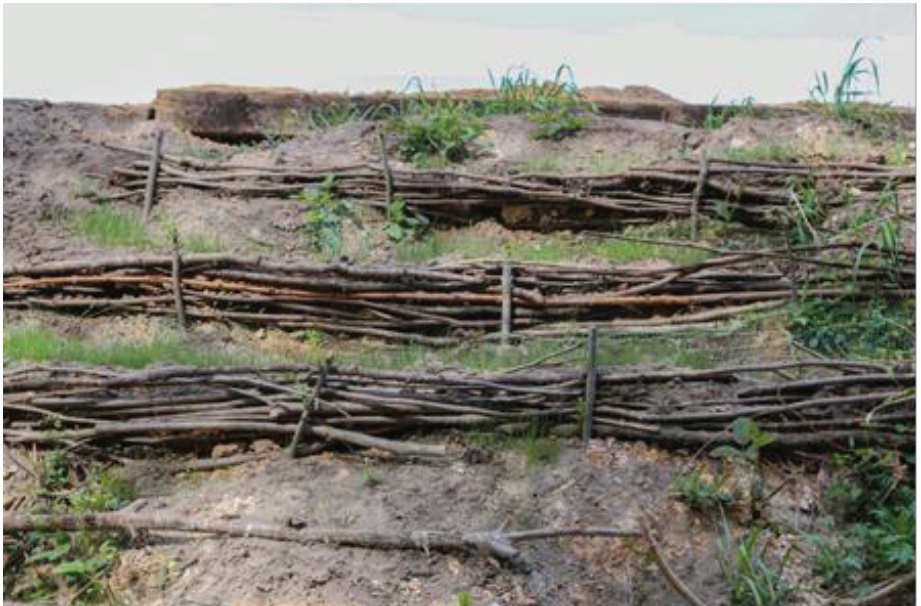
Image 2 - Example of measures to be applied on slopes/hillsides (Source: ICNF)

- On **sloping areas, create barriers along the contour lines, using dead vegetation**, this will retain sediments and minimize water run-off, allowing better water infiltration (see image 2).
- **Fill the space** between the barriers **with mulch**, using existing litter if possible;
- You can also create **small ditches on contour to retain organic matter and water run-off**.
